Tanti Creek Friends

Tanti Creek, Mornington

Summary of Litter, Erosion & Siltation threats to Creek Health

Prepared by:
Martin Lenard
24th January 2017

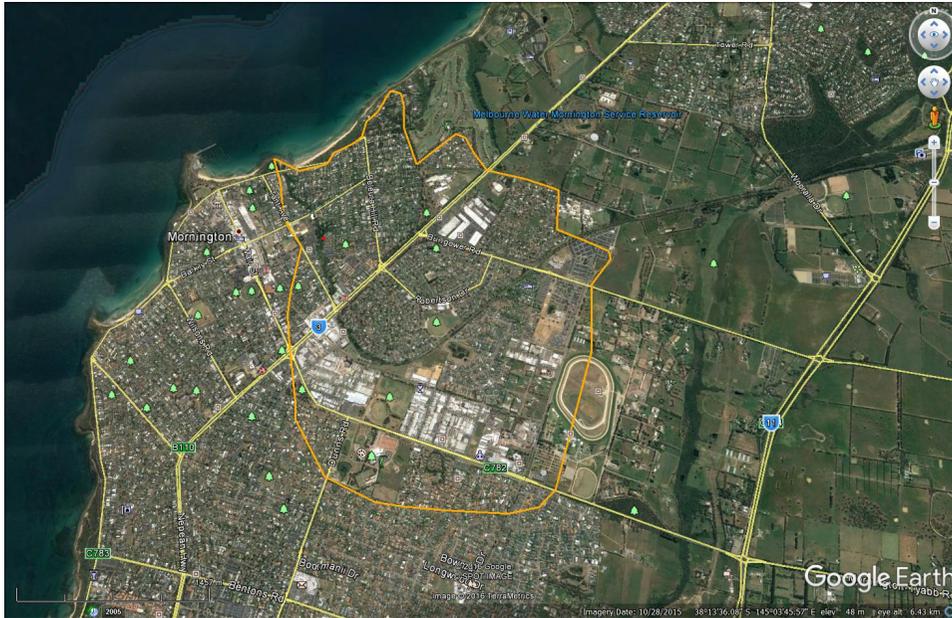
Tanti Creek is an urban waterway with a catchment of approx 7 square km (orange line on Google Earth image).

The catchment comprises residential, commercial and most of Mornington's light industrial areas.

- Extensive development within its catchment has resulted in increasing flow volumes and velocity. This results in creek erosion and siltation.
- Litter from stormwater drains and erosional debris pollutes the creek and the bay

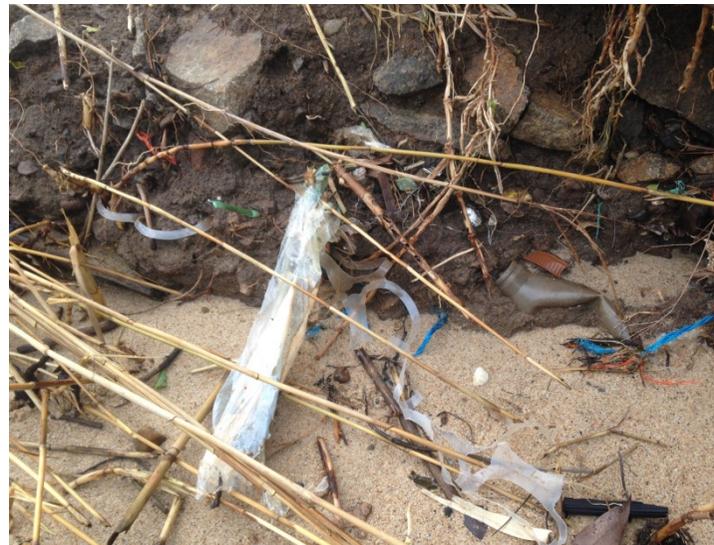
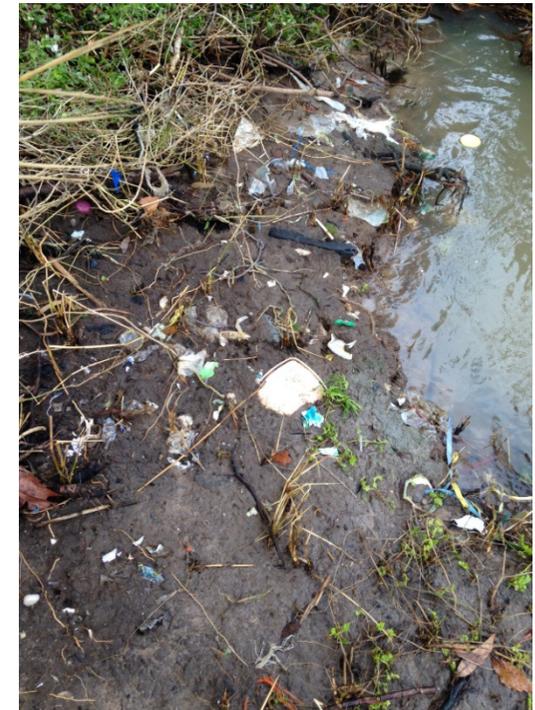
- Litter is not a new problem for Tanti Creek
- Erosion of the creek banks at the Tanti Estuary is exposing “historic” litter buried in the silt and mud (photo to the right and detail below).

“Palaeo” litter at Tanti Creek Estuary

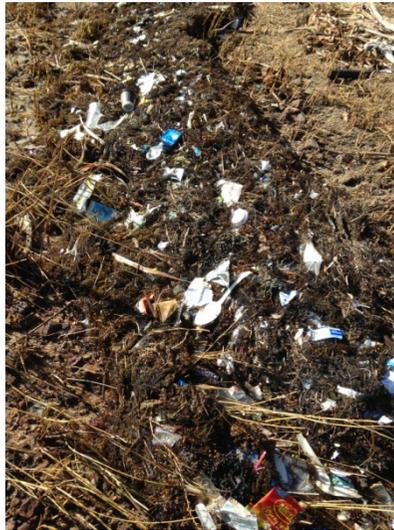
High tide litter at the Estuary

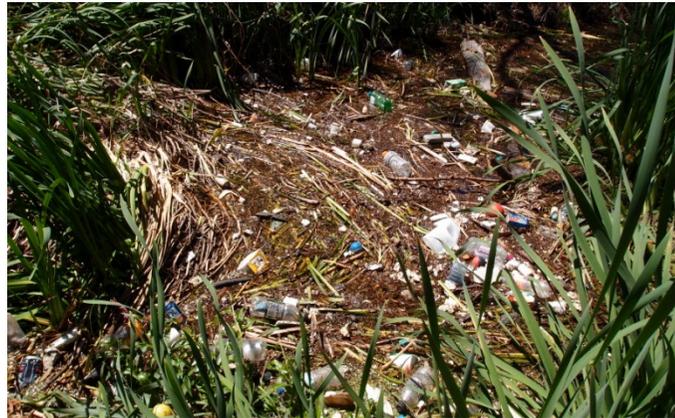
Rubbish near Creek Rd, Jan 2017

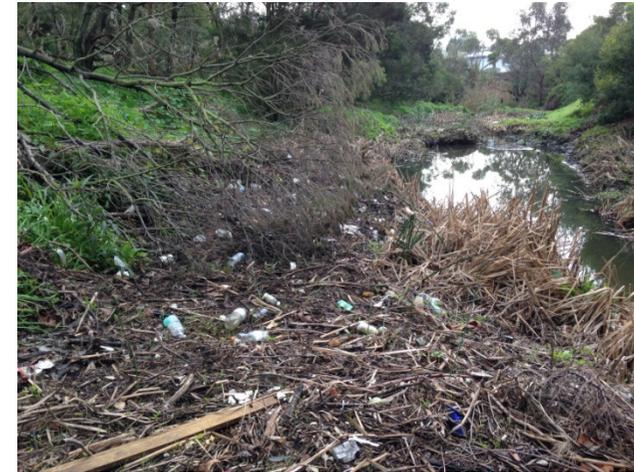
Rubbish near Creek Rd, June 2016

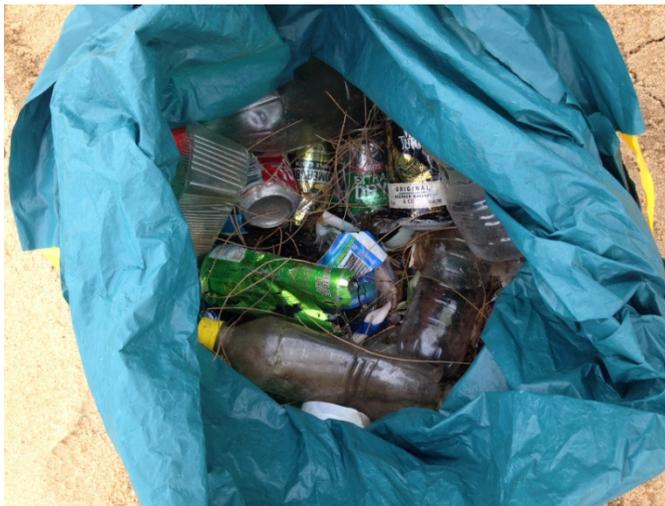
- Jack Knobel reported that following the 24mm of rain on Fri 20th Jan it took “hours and hours” to clean up the litter at the Tanti Creek Estuary.
- Helen Lovett also showed me the litter collected from her section of the beach after this rain event. Helen mentioned that if southwesterly winds occur after rain she sees a significant increase in litter (sourced from Tanti Creek). This material has been washed over 1km from the creek mouth.

Litter collected by Helen after the 20/01/2017 rain

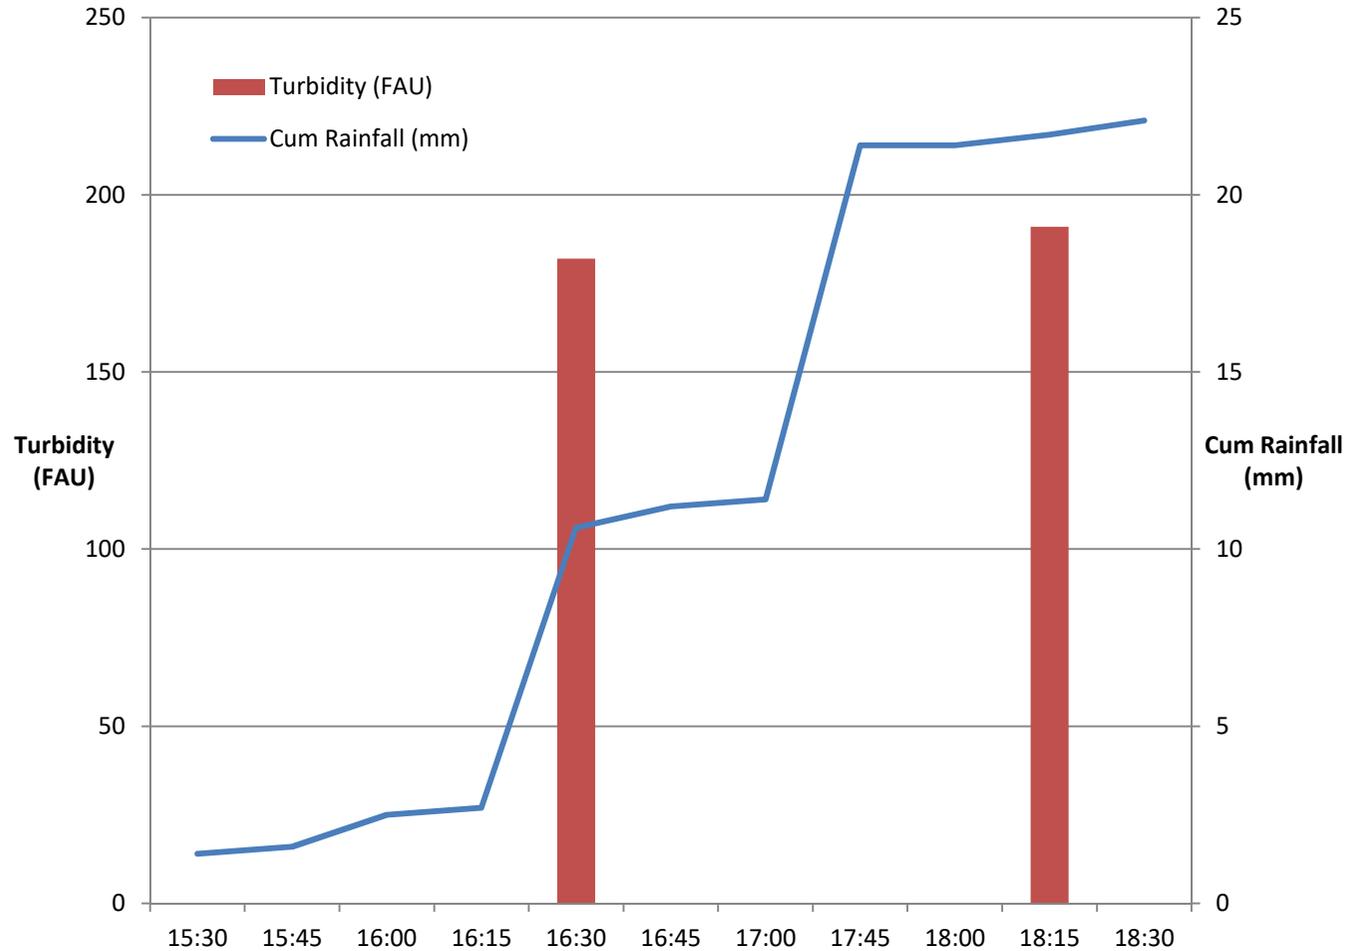
The turbidity measured in Tanti Creek during rain events is 10 times the typical level in healthy waterbodies and above the level that may cause ecosystem damage.

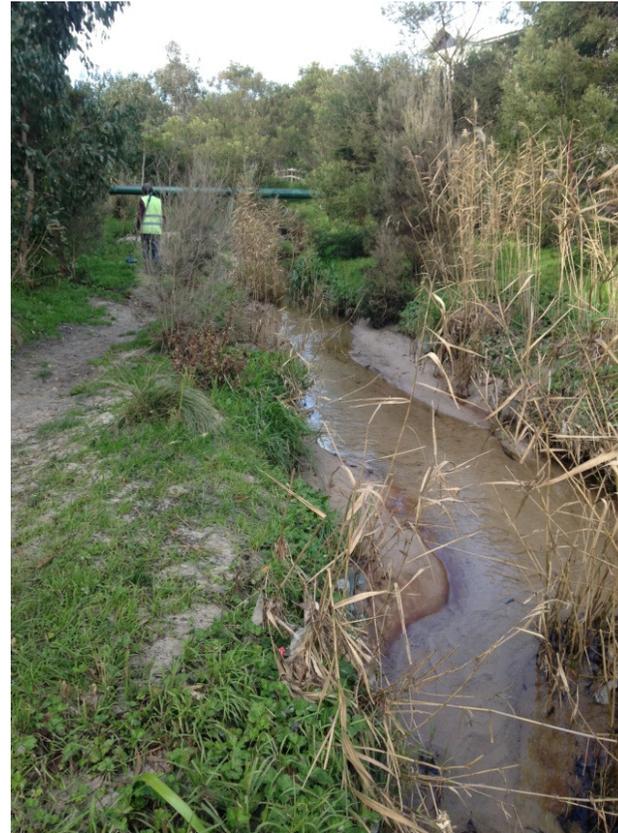
Tanti Creek 8th August 2016

This is Waterwatch monitoring site ETN 900 close to the Estuary. The creek has silted up so much in the past 2 years that the creek is now too shallow to sample.

- 50m upstream of Stones Crossing
- 50m upstream of the Esplanade road bridge (Waterwatch Site ETN 900)

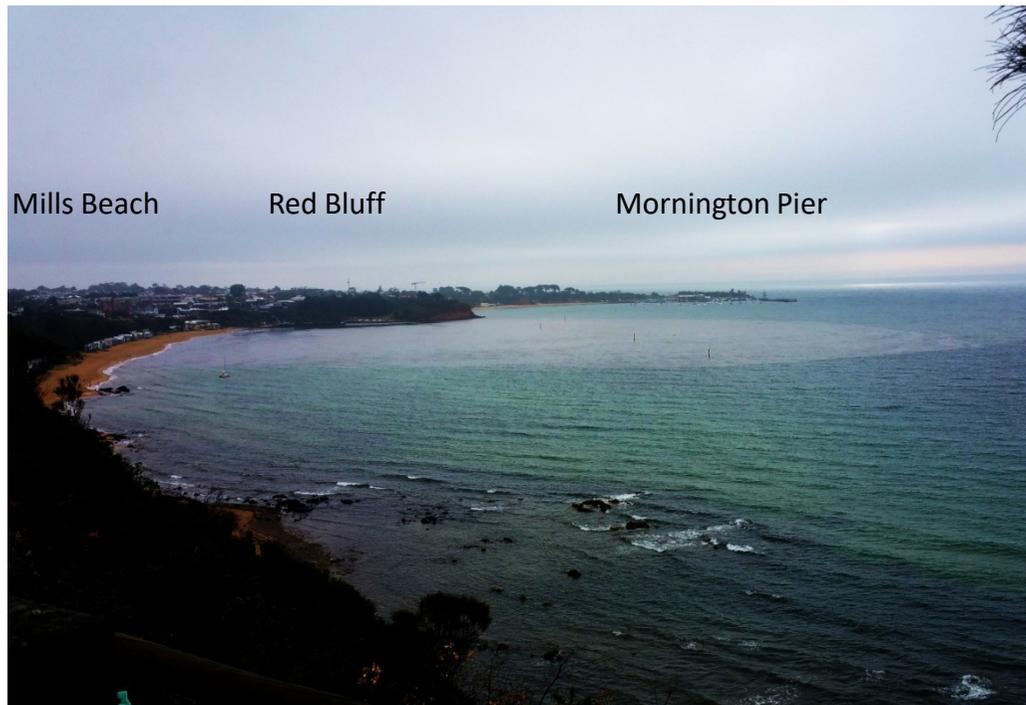
This photo shows the plume of sediment resulting from the high turbidity creek flows on 29/12/2016 (see slide 12).

The sediment-laden water extends at least 300m out to sea and 400m along Mills Beach.

Peter Nicholson (who took this photo) advises that he has observed much larger plumes from Tanti Creek (this was a 24mm rain event).

The short and long-term impacts of this sedimentation on the Tanti estuary, coastal marine environment and Mills Beach are not known.

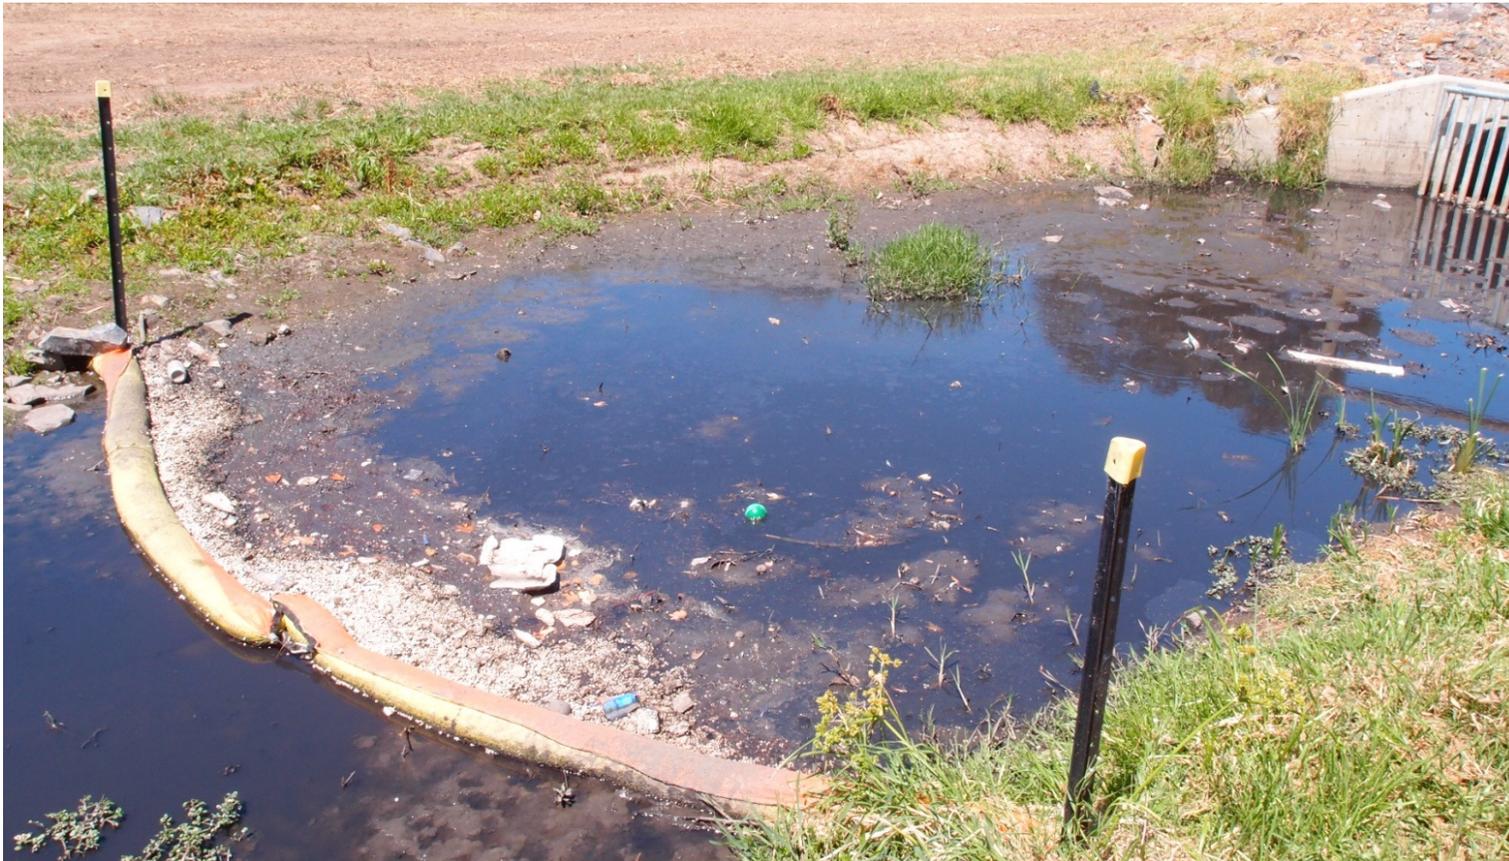
- Pollution
 - Utilise the Archer Retarding Basin to create a wetlands that actual removes pollutants from the drainage.
 - This drain is the main source of organic pollutants into Tanti Creek (refer below)
